WATER QUALITY EVALUATION

Technical Memorandum

B&V PROJECT NO. 406304

City of Folsom

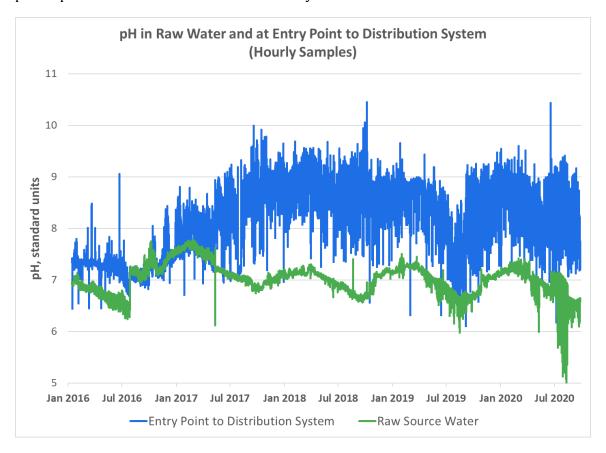
Figure 3: pH Measured Hourly at the Entry Point to the Distribution System and in the Source Water

pH in the raw source water displays seasonal fluctuations with the pH dropping slightly in summer and fall when the water temperatures increase and biological activity increases. These trends can be observed in the treated water at the entry point. Additional lime would be necessary in the summer and fall to keep a consistent pH, which would result in a higher LSI value (a less negative number).

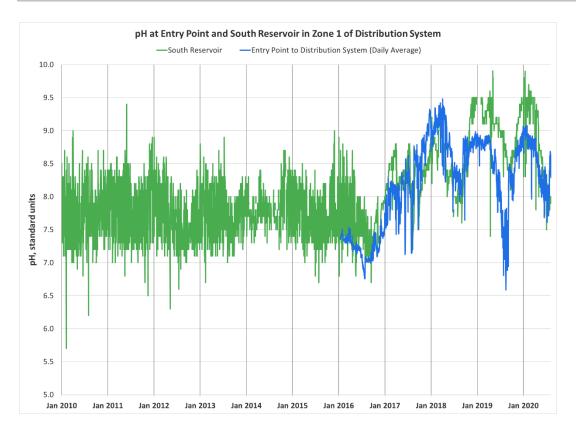
The pH exceeded 9.0 in Zone 1 of the distribution system in the fall of 2018 as seen in Figure 5. The same results were seen in Zone 2 and Zone 3 of the distribution system as displayed in Figure 6 and Figure 7, respectively.

Figure 5: pH at Entry Point and Zone 1 (South Reservoir)

Based on findings of Dr. Edwards research at Virginia Tech, pH levels of 9.0 and greater (such as the ones measured in Zones 1, 2 and 3 in 2018, much of 2019, and the start of 2020) combined with the low alkalinity pure water and the use of free chlorine as a disinfectant could have created pitting conditions within copper piping based on research with similar water qualities [1, 2]. Since the City uses a relatively low free chlorine residual of approximately 1 mg/L, it could explain why the onset of pinhole leaks occurred approximately two years after increases in pH from the WTP treating the quality of raw water existing at the time in order to meet the LSI targets.

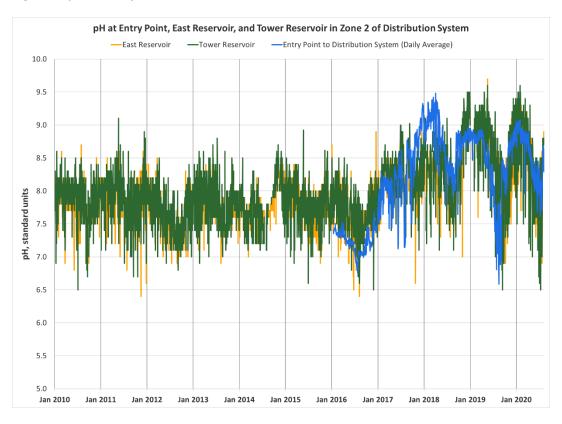
Figure 6: pH at Entry Point and Zone 2 (East Reservoir and Tower Reservoir)

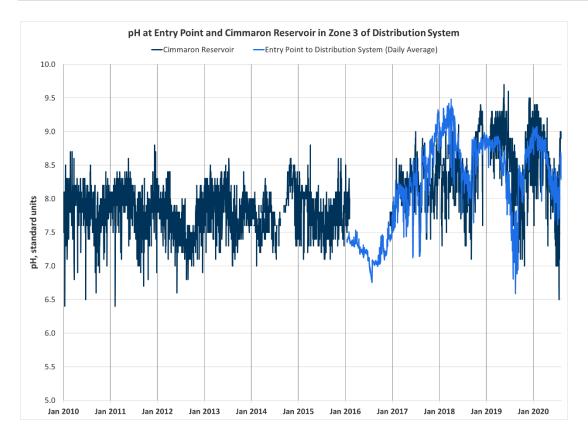
Figure 7: pH at Entry Point and Zone 3 (Cimmaron Reservoir)

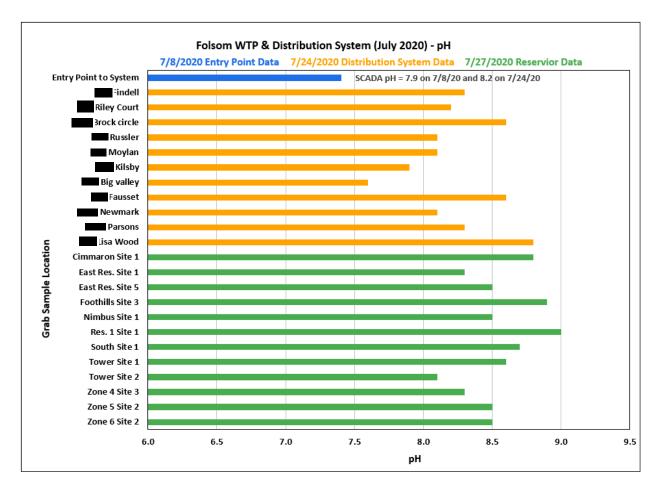
A comparison of how water quality can change throughout the distribution system is shown in Figure 9, where pH grab sample data were compared from July 2020 for the entry point, multiple locations in the distribution system at or near locations with pin hole leaks, and at the reservoirs. The samples were collected on different days as the entry point grab sample was collected on July 8, 2020, the distribution system samples were collected on July 24, 2020, and the reservoir samples were collected on July 27, 2020.

To provide extra context to the data, the online pH analyzer from the entry point was included on Figure 9 to show how the pH was measured as 7.9 with the online analyzer on July 8, 2020 yet the grab sample result was 7.4. Additionally, the online analyzer pH result was 8.2 at the entry point on July 24, 2020 when the distribution system samples were collected. Figure 9 shows the variability in pH through the distribution system, as on a single day, the pH levels differ by up to 0.9 pH units when comparing different reservoirs. The distribution system samples show a difference of up to 1.1 pH units. Due to the low buffering capacity of the water it is difficult to maintain a consistent pH, but the swings in pH should be minimized.

Figure 9: pH from WTP, Reservoirs and Distribution System Grab Samples in July 2020

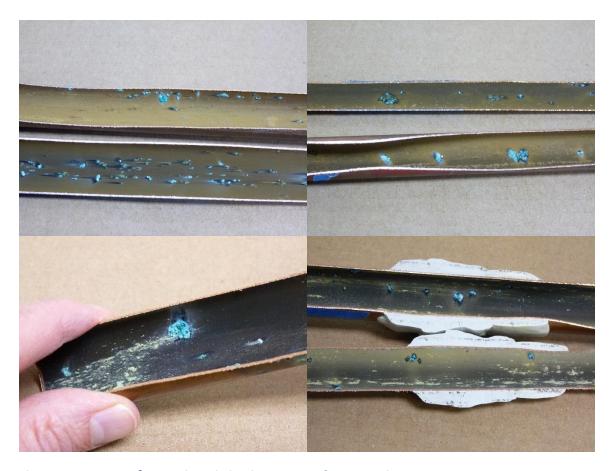
Scale analysis was performed on eight harvested copper pipes from locations that experienced pin hole leaks in the City's distribution system. After the materials were harvested from premise plumbing the samples were shipped to the Virginia Tech ICPMS Metals Analysis Lab for scale analysis. Images of pitting and pinhole leaks in some of the copper pipes are shown in Figure 11.

Pitting corrosion is a localized type of corrosion at specific sites the size of the tip of a pen on the interior of pipe walls. Pitting involves the removal of copper ions from a specific site and then they are deposited in corrosion scale around the pit as shown by the blue/green sites in Figure 11. As the pit continues deeper and deeper into the pipe wall, the corrosion scale grows, and the water quality is changed at this microscopic location. The removal of copper ions makes the pit become acidic (more corrosive) and it draws in chloride and sulfate ions to try and regain electroneutrality, but in the process it makes the pit salty (increases corrosivity). These changes in water quality along with changes in flow patterns in the pipe as a result of the buildup of pipe scale create conditions that can continue pitting to the point when a pin hole leak occurs.

Figure 11: Images of Corrosion Pitting in Harvested Copper Pipes

- The primary elemental composition of the corrosion pits was approximately 60 percent copper and 30 percent oxygen, by weight, indicating that the pits were likely copper oxide.

- Copper was the main element found in the pitting corrosion along with trace amounts of aluminum and silicon. Aluminum is notable as recent research has shown aluminum concentrations of 0.5 percent by weight or more can catalyze copper pitting in very clean waters at pH greater than 9 with free chlorine [1, 4], which describes the City's treated water at various times throughout the year. The sources of aluminum were not identified in this analysis and it is recommended that the City continue to conduct lab analysis for Aluminum. Aluminum is recognized by the EPA under its National Secondary Drinking Water Regulation with an MCL of 0.2 mg/L. The City's records indicate that the treated water samples indicate a "non-detect" for Aluminum. Pitting can potentially occur due to a pH above 9, low alkalinity, and free chlorine, but the presence of aluminum could speed up the reactions since the aluminum present in the pipe scale was greater than 0.5 percent in all samples.

- The sulfide "spot test" came back negative, thus, eliminating sulfite reducing bacteria as a potential cause for the pitting.
- There was no evidence of microbial activity in the harvested pipes; therefore, microbial induced corrosion was ruled out as a cause for the pitting.

- The copper pipe thickness ranged between 81 and 91 percent of the American Society for Testing and Materials (ASTM) specification for Type M copper, but since the harvested pipes were installed 20-50 years ago, they were deemed not defectively thin.
- Some leaks appeared to have sealed themselves through a process known as autogenous repair.
- There was no observed difference in the pipe scale when comparing the pipes on cold water services with the pipes on hot water services. This area of research is not well defined yet.
- The results of scale analysis indicate that pH increases (over the last few years), low alkalinity (<40 mg/L as CaCO₃) pure water treated with free chlorine could potentially contribute to pitting.

The use of orthophosphate has been shown to inhibit pitting in aggressive waters by hindering pit initiation as a passivating scale will develop on the interior of copper pipes, and it can help to slow or even mitigate pit propagation on pits that are already initiated. It is critical to use an appropriate dosage of orthophosphate, which is why monitoring in the distribution system is necessary as research has not defined a critical threshold level of orthophosphate as it depends on the water quality and system specific conditions (e.g., flow velocity and frequency) [2].

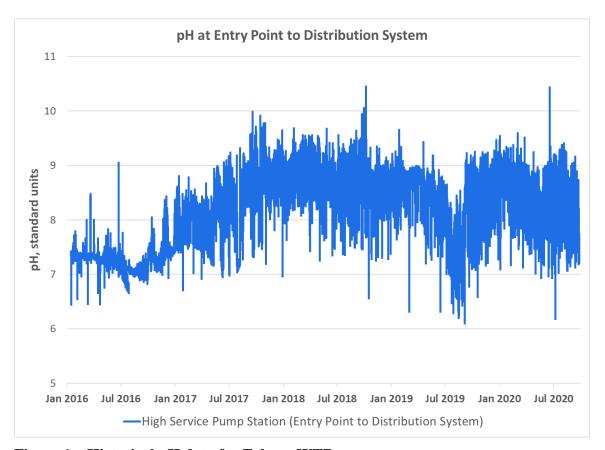
A review of the historical water quality data shed some light on the copper pitting issue. In over 10 years of dedicated research, the Edwards research group has only been able to reproduce copper pitting in a laboratory setting with water that exhibited these characteristics: high pH (9.0 or greater), low alkalinity, and high chlorine concentrations (see Sarver et al. for details²). A close look at the pH data for water leaving the Folsom WTP shows that the pH increased from about 7.5 prior to 2017 to around 9.0 beginning in summer/fall of 2017 (**Figure 1**). Additionally, pH exceeded 9.0 on numerous days after this change, and frequently exceeded 9.2. These conditions have made the water at Folsom a candidate for copper pitting based upon our laboratory experience, especially given the pristine condition of Folsom surface water and limited amounts of alkalinity and hardness. Any impurities present on the older copper pipes in this study cannot really explain a sudden outbreak of leaks as impurities are present on all copper pipes. Ironically, the higher pH that is desirable to reduce corrosivity for lead and copper under

Figure 1 – Historical pH data for Folsom WTP
