# Southern Pacific Depot & Superintendent House Historic Structures Reports

City of Folsom City Council Presentation 4/11/2023

# Folsom Depot – Overview of Findings & Recommendations

# Superintendent House– Overview of Findings & Recommendations

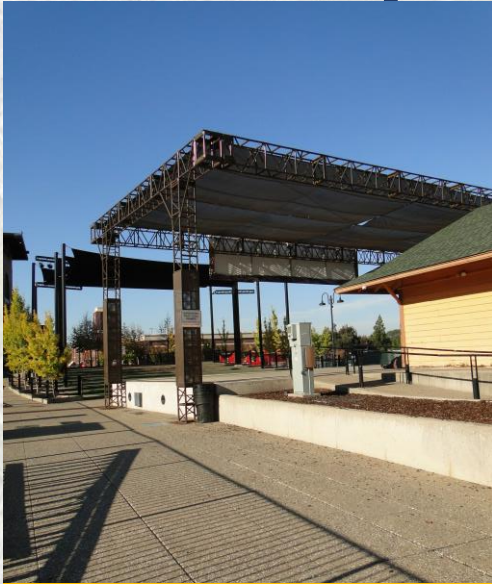
Site

- **Finding:** site maintains both historic & non-historic elements
- **Recommendations:**
  - Maintain historic elements
  - Provide city standards plantings

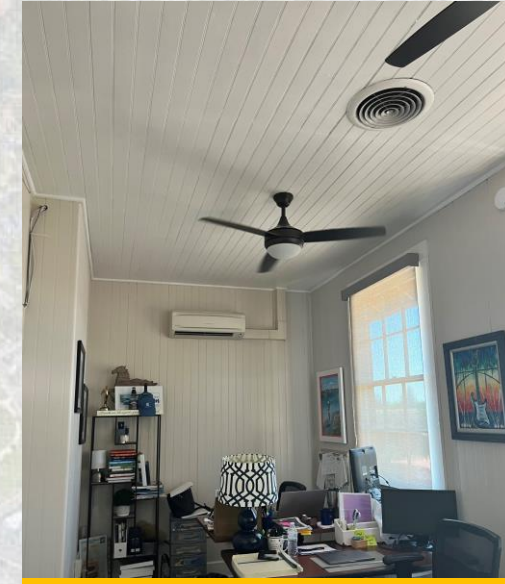
Interior Finishes

- **Finding:** Interior contains primarily historic finishes
- **Recommendations:**
  - Repair and refinish historic finishes

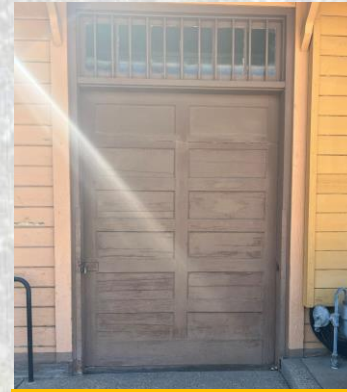
Freight Door

- **Finding:** original Freight doors remain in varying condition.
- **Recommendation:** Restore doors and replace hardware

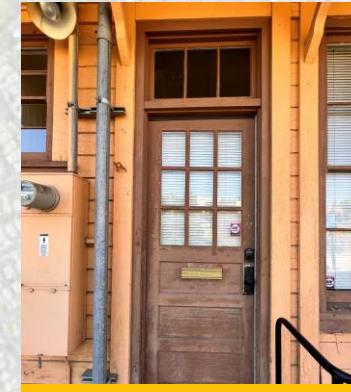
Exterior Doors

- **Finding:** Original exterior doors, some damage and dry rot.
- **Recommendations:**
  - Restore doors & replace hardware

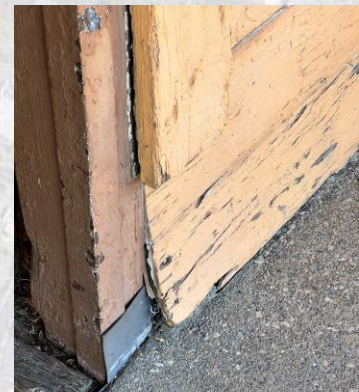
Exterior Siding

- **Finding:** Original siding showing signs of damage and dry rot.
- **Recommendations:** Restore, repair, replace, and repaint

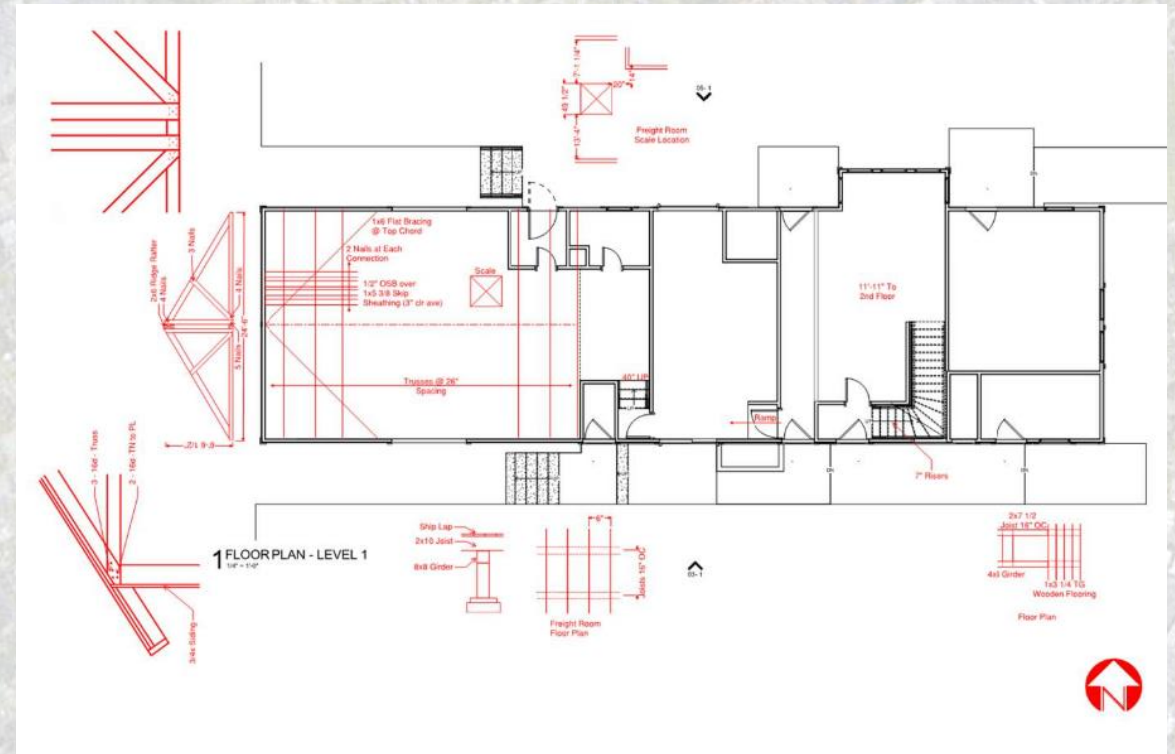
- **Finding:** The roof trusses at the upper level have dis-continuous bottom chords at stepped ceiling.
- **Recommendations:** A continuous cross tie across roof trusses at the upper level.

- **Findings:** The current under-floor crawl space clearance is inadequate for access, ventilation and protection of wood members.
- **Recommendations:** Excavation of under-floor crawl space between girders to 18" minimum at joists and 12" minimum at girders per code.

*\*In addition, structural recommends a seismic evaluation of the structure according to ASCE 41 Tier 1 checklist to determine any additional items of concern.*

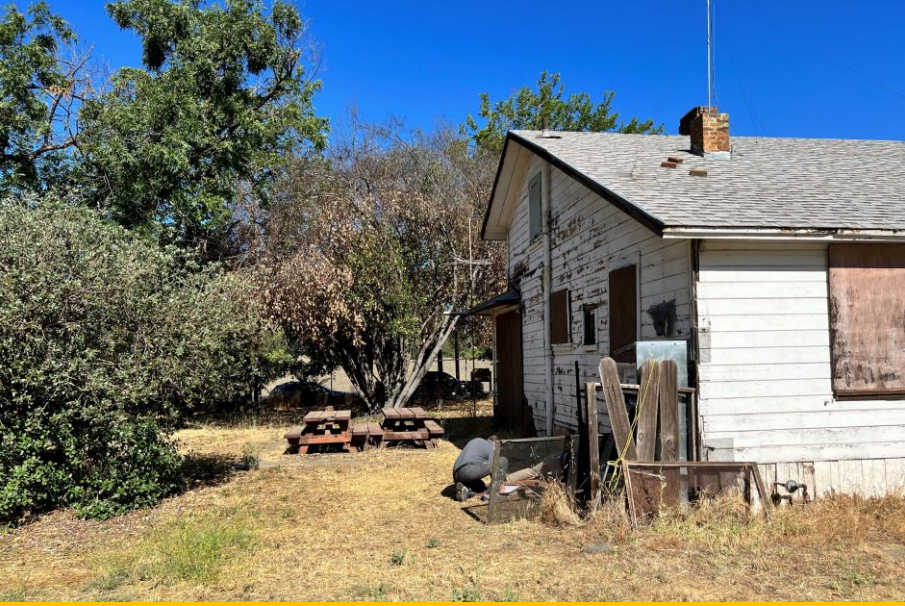
Site

- **Findings:** Overgrown and inaccessible
- **Recommendations:**
  - Maintain historic features
  - Convert site for future public use.
  - Rehabilitate grass and plantings.

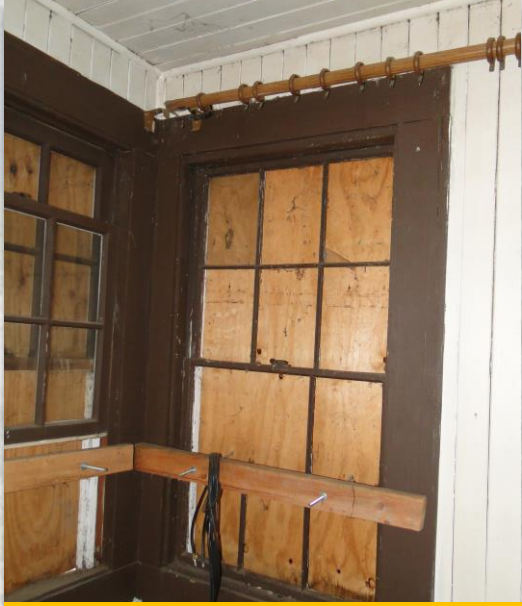
- **Findings:** Windows remain in poor condition.
- **Recommendations:**
  - Restore original windows. Provide new where missing

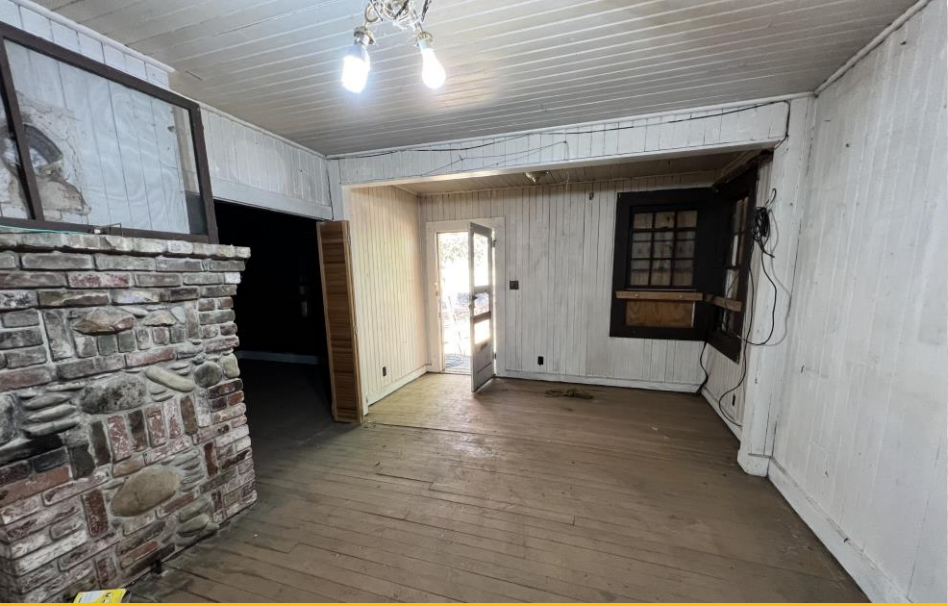
House interior

- **Findings:** Generally historic finishes in fair condition
- **Recommendations:**
  - Restore original finishes and remove non-original finishes

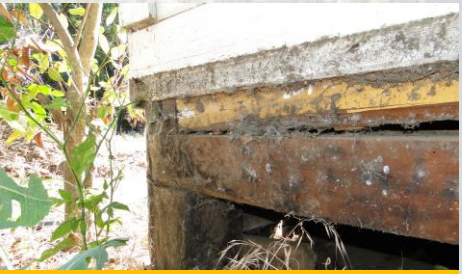
- **Findings:** Siding and trim generally in poor condition
- **Recommendations:**
  - Restore, repair, & replace siding.
  - Restore or replace skirting.

Missing Skirting

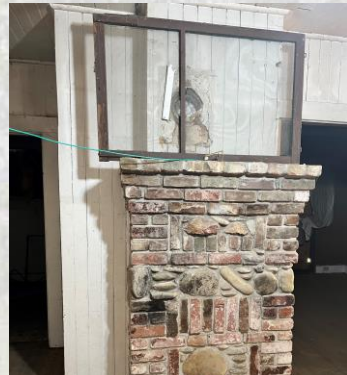
Fireplace

- **Findings:** Chimneys are deteriorated & unstable
- **Recommendations:**
  - Restore chimneys and stabilize
  - Remove brick & reface fireplace.

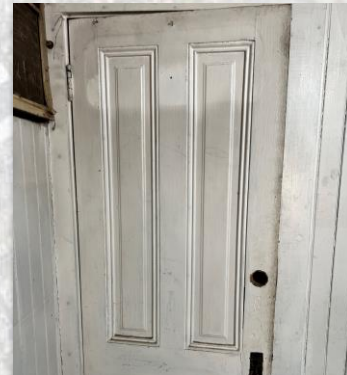
Original Door

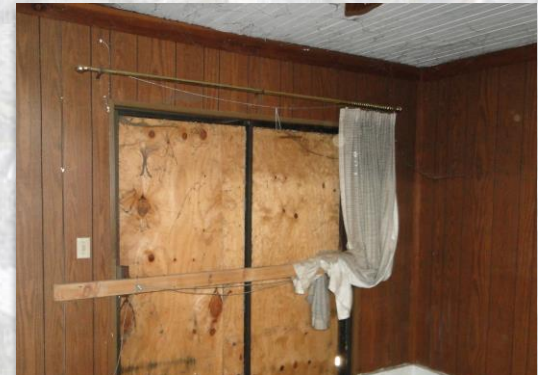
Non-original door

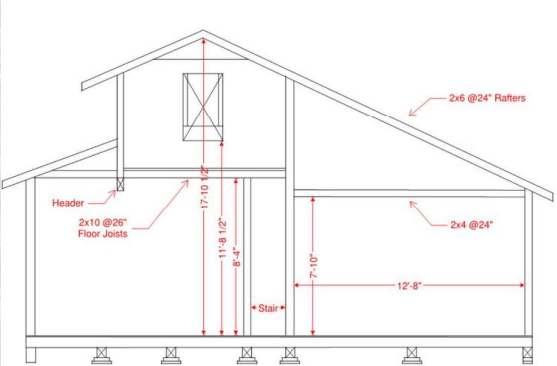
Figure 6: North Section of Structure

- **Findings:** The current under-floor crawl space clearance is inadequate for access, ventilation, and protection of wood members.
- **Recommendations:**
  - Provide minimum clearances under floor girders
  - Raise structure and install permanent foundation
  - Tie walls to foundation
  - Provide positive drainage
  - Complete a termite inspection prior work.
