April 25, 2024

PRELIMINARY ARBORIST REPORT, TREE INVENTORY & PROTECTION PLAN

RE: 603 Sutter Street, APN #070-0111-010-0000; City of Folsom jurisdiction, California

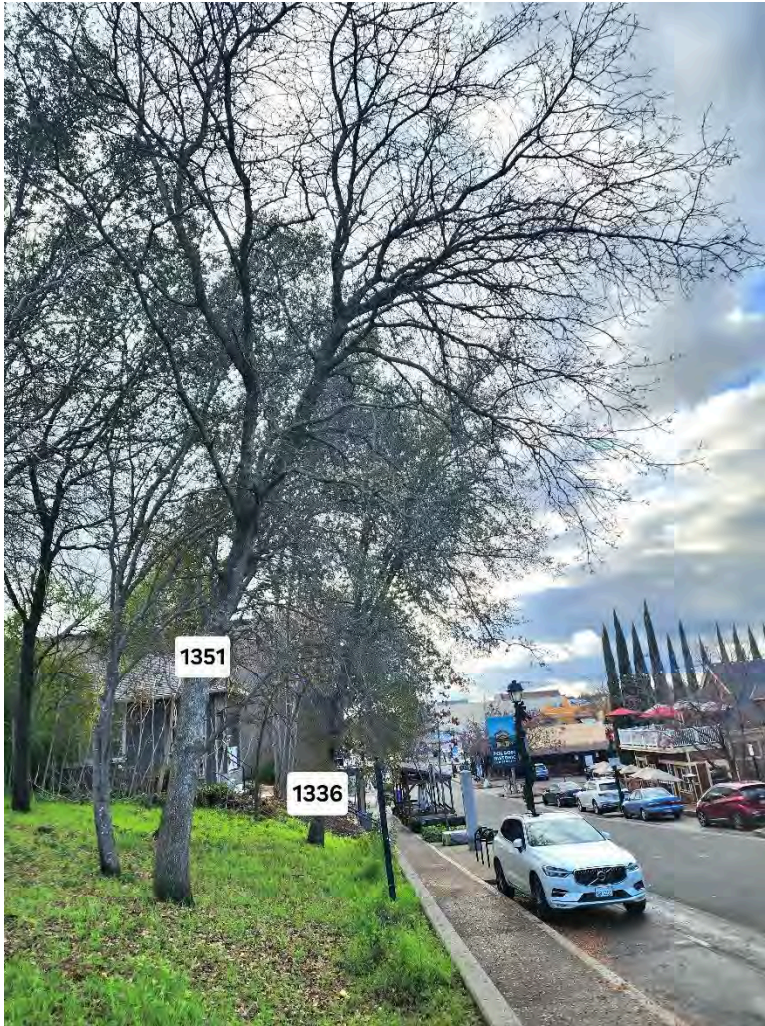
Photo #1, Shows Trees #1351 & #1336, from left to right

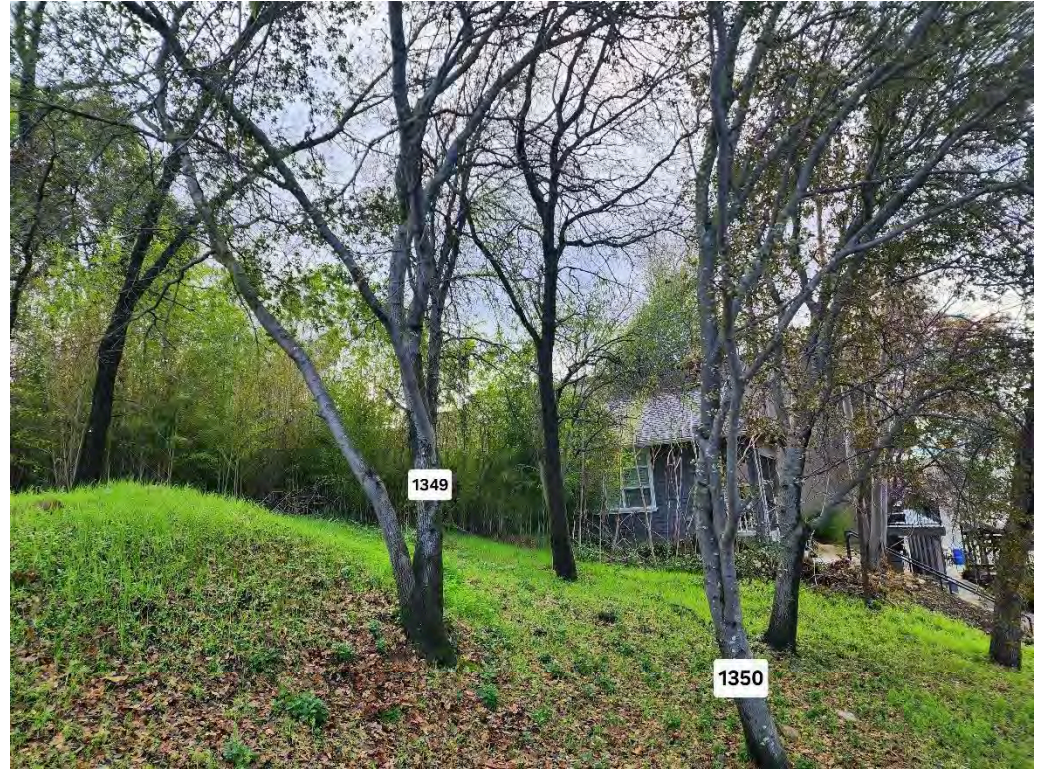
Photo #2, Shows Trees #1349 & #1350, from left to right

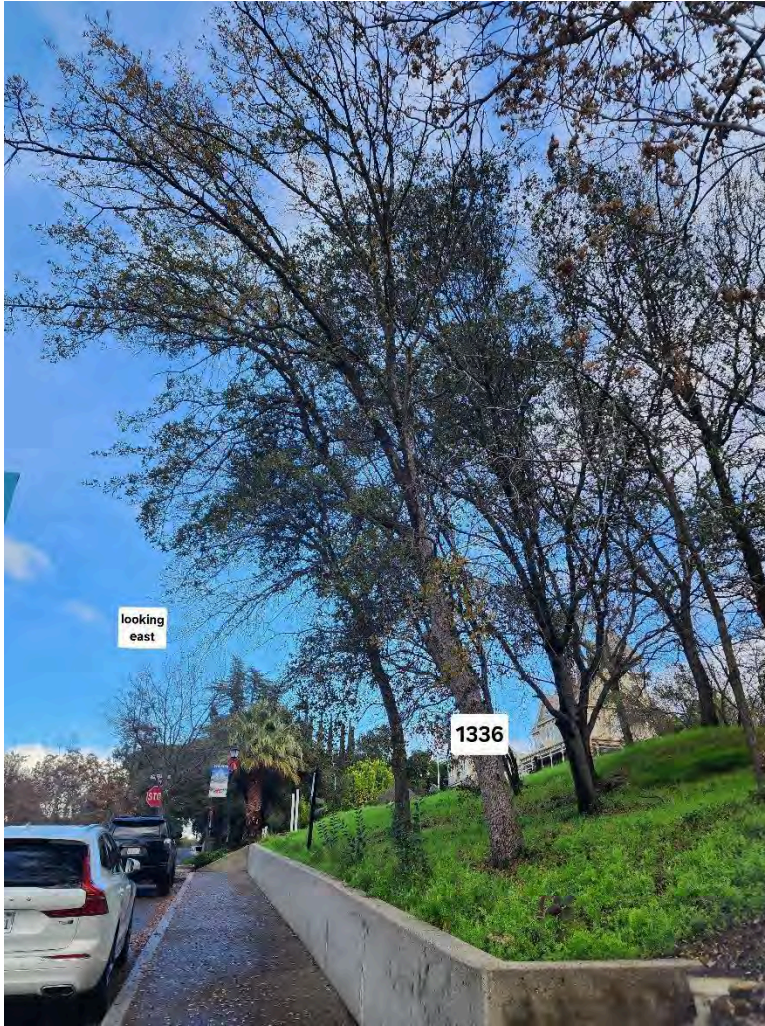
Photo #3, Shows Tree #1336, looking east

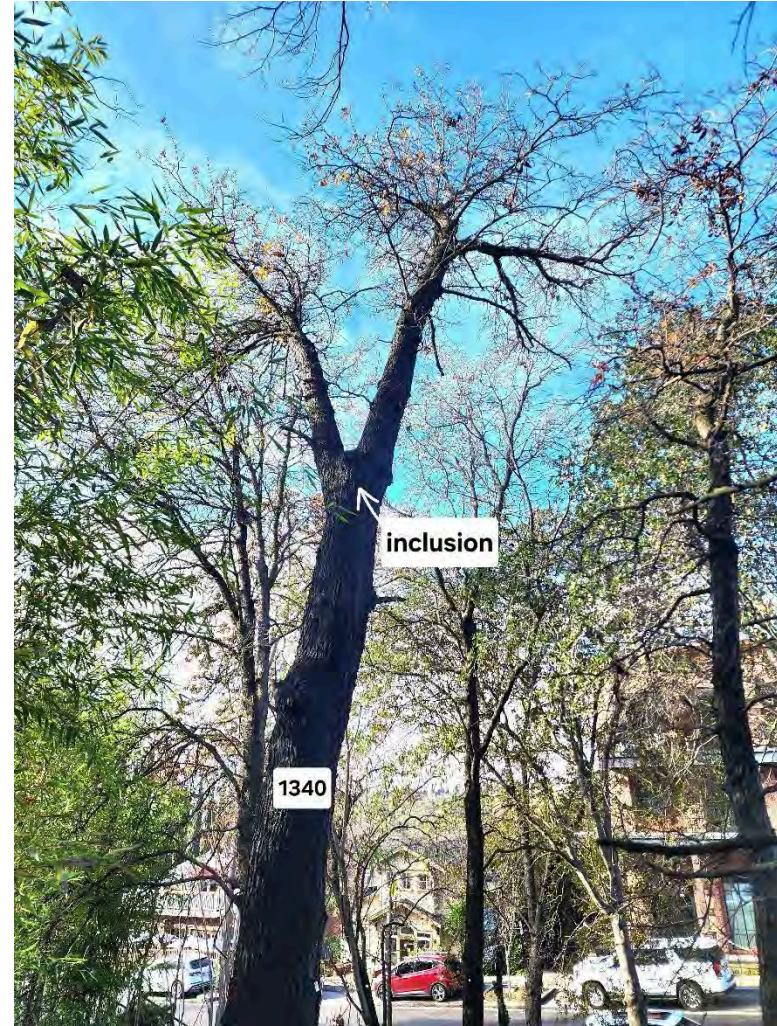
Photo #4, Shows Tree #1340, with visible elevated/swollen inclusion below codom union

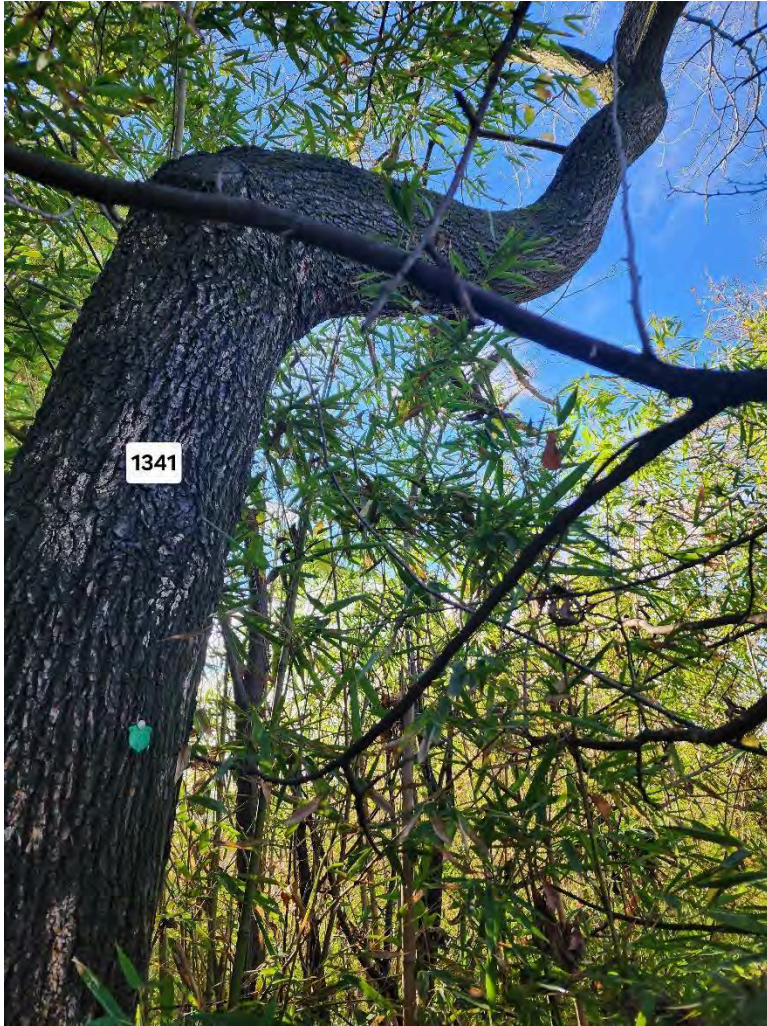
1341	915			Pecan	<i>Carya illinoensis</i>	13.5		54	30	2 Major Structure or Health Problems	good base. unbalanced trunk, takes 90 degree turn north at 10', corrects back upward at 12'. branch die back in canopy. fair/low vigor.	Proposed for removal
1342	23773			Camphor	<i>Cinnamomum camphora</i>	26		12	23	3 Fair - Minor Problems	good base. multi stem at 5'. fair structure, rubbing canopy stems. moderate branch die back in canopy. good vigor.	Proposed for removal

Photo #5, Shows Tree #1341

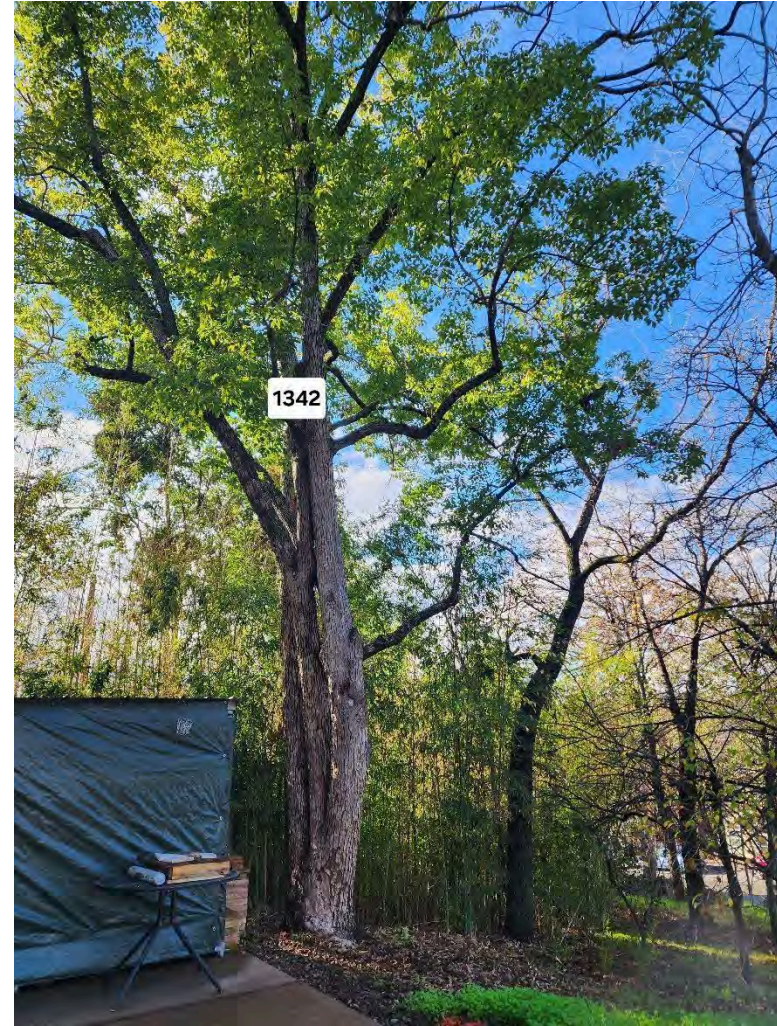
Photo #6, Shows Tree #1342, multi stem at 5'

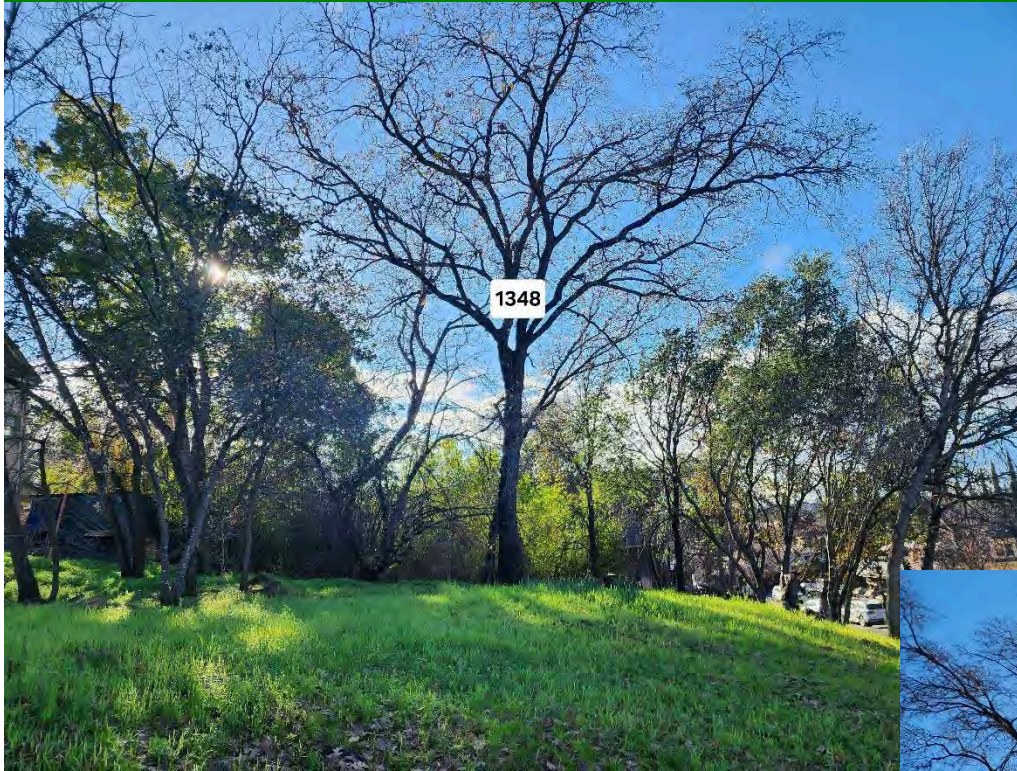
Photo #7, Shows Tree #1348

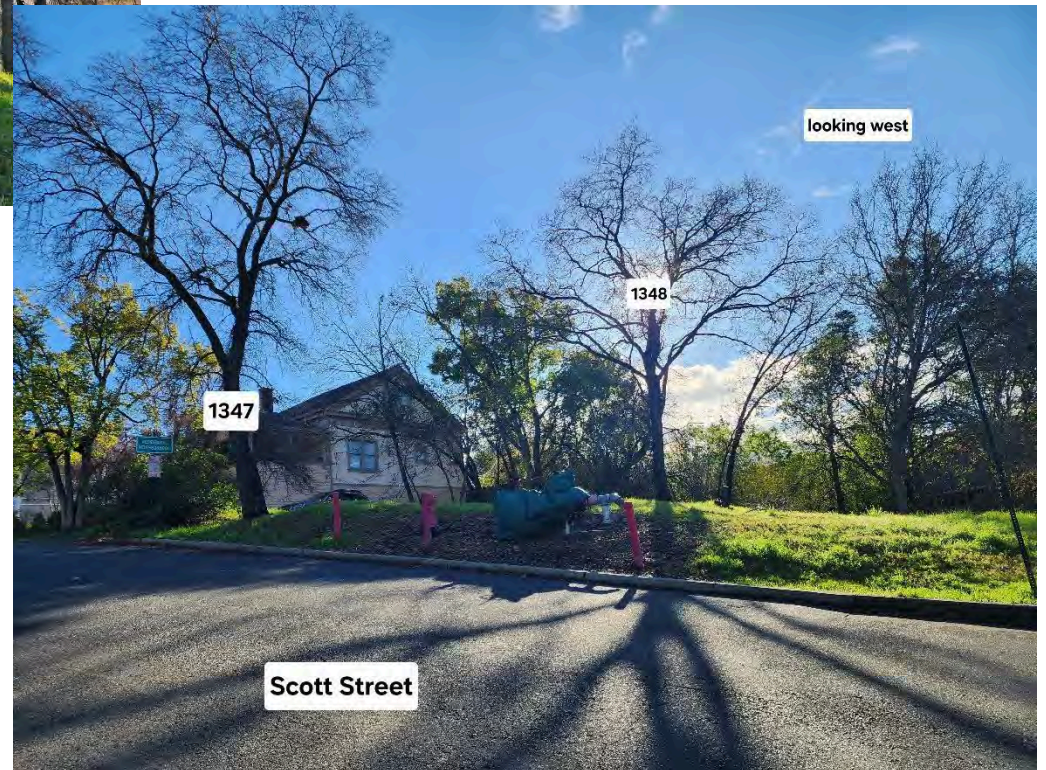
1347		Yes		Valley oak	<i>Quercus lobata</i>	19		54	31	3 Fair - Minor Problems	fair flare, 6 feet from scott street. codominant at 15 feet. fair crown balance and density. branches overlap scott street by approximately 14 feet. fair vigor.	Proposed for removal
1348		Yes		Valley oak	<i>Quercus lobata</i>	17		54	27	3 Fair - Minor Problems	slightly swollen base. good trunk. good canopy structure. good vigor.	Proposed for removal
1349				Interior live oak	<i>Quercus wislizeni</i>	13	8, 5	54	16	2 Major Structure or Health Problems	growing on slope. partially buried root collar. swollen codom union. codom at 1'. fair structure, crossing, touching	Proposed for removal

Photo #8, Shows Trees #1347 & #1348, looking west from Scott St.

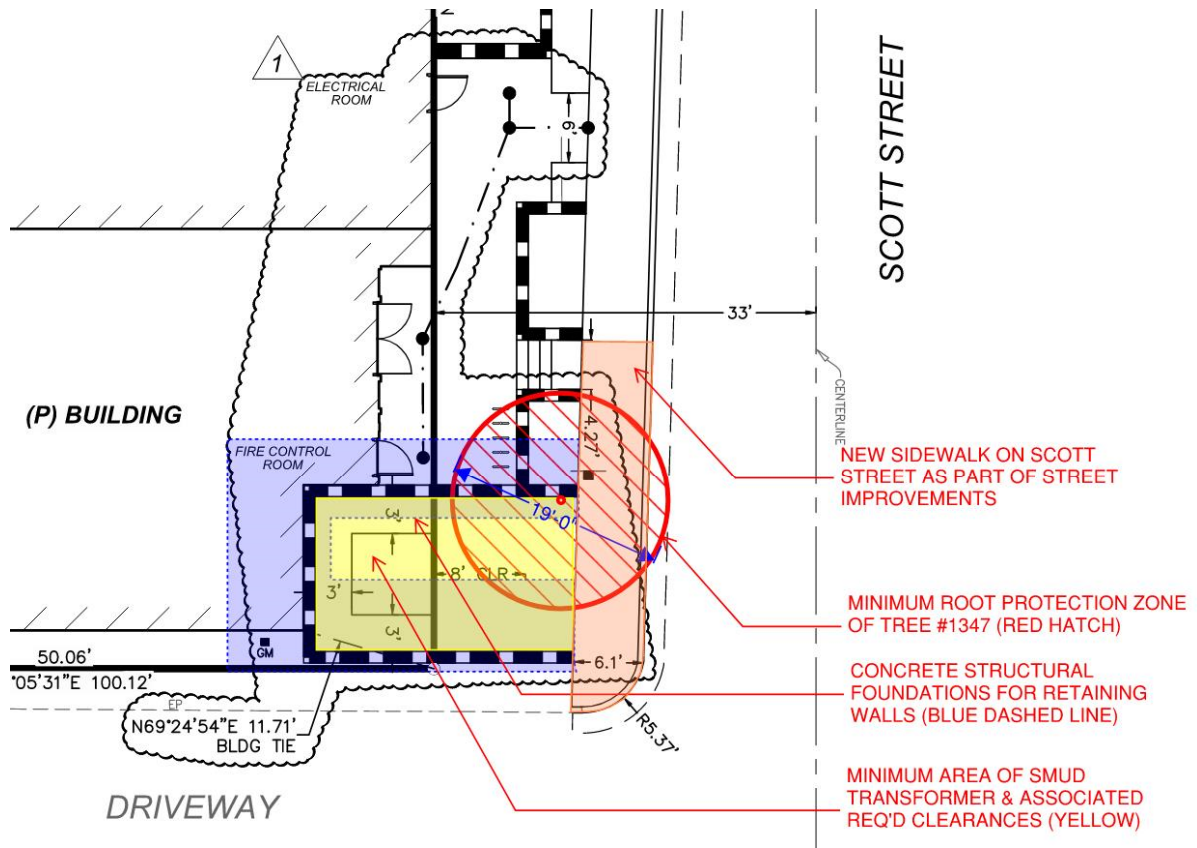
EXHIBIT A - ROOT PROTECTION ZONE FOR TREE #1437 OVERLAYED WITH DEVELOPMENT ELEMENTS WITHIN THE VICINITY

1. The Root Protection Zone (RPZ): In most construction sites, it is not possible to protect the entire root zone of a tree, so an RPZ is established (as outlined in the project Arborist Report). The minimum root protection zone is the area calculated as 1-1.25' for every inch of trunk diameter (i.e. a 10" diameter tree will have an RPZ of 10') or the dripline if required by the local ordinance. **Tree #1347 is a 19" Valley Oak, so the minimum RPZ would be 19' – 24' (see attached Exhibit A with the minimum RPZ of 19'-0" indicated).**

4. Street Improvements on Scott Street: One of the conditions of the Entitlements approval were public frontage improvements at Sutter Street and Scott Street. This included the continuation of the sidewalk up Scott Street. It would not be possible to continue the sidewalk along the entire Scott Street as it falls within RPZ.
