August 28, 2024

R.E. – Valley oak in back yard

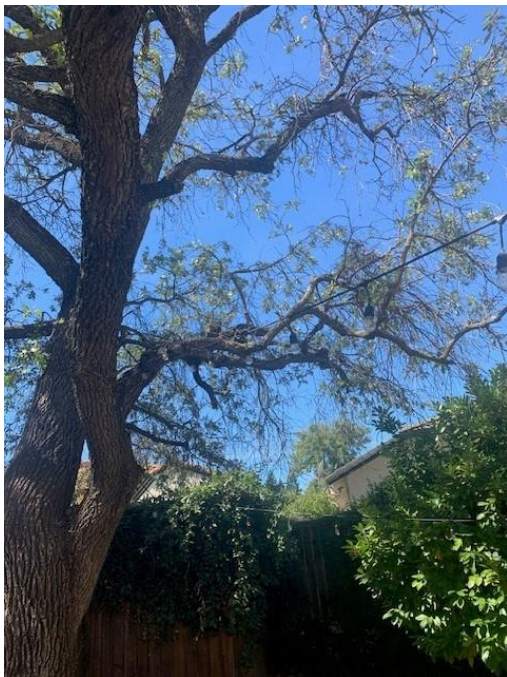
Exhibit a

This tree has poor vigor and appears to be in decline. At the time of inspection, the crown was thin and has a lot of dead branches (exhibit a). On the Southeast side of the tree there is a large wound (Exhibit b) and by the size of the callus roll it happened during construction. There is a similar wound on the southwestern side as well (exhibit c). At the base of the tree there are two significant pockets of decay (exhibit d & e). Using a metal probe, you can feel soft wood under the buttress roots and butt of the tree. Sounding hammer confirms significant decay around almost half the tree's base. This decay has severely impacted the structural integrity of the tree and whole tree failure is likely.

Based on these findings, I find the tree to be a high risk to people and property and should be removed. ASCA rating is 1.
