**Corridor Summaries**

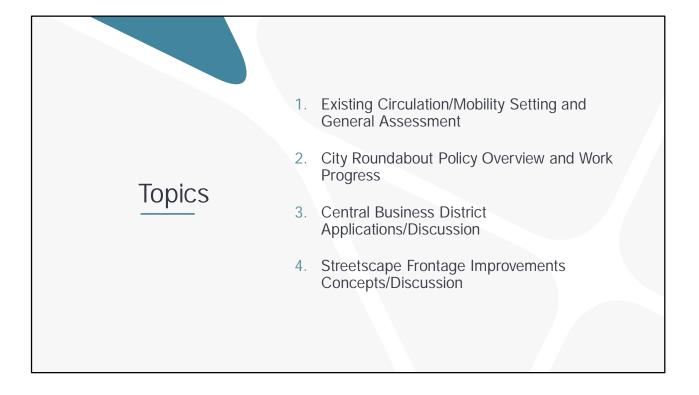
Existing Setting Summary Matrix						
		Approximatley @ Glenn		Between East Bidwell-Riley		
		East Bidwell	Riley			Orchard
	General Plan Classification	Major Arterial	Major Arterial	Major Arterial	Minor Collector	Minor Collector
	Right-of-Way Width (ft)	70	80	60	60	58
	Existing/Future #Lanes	4	4	2	2	2
	Existing Average Daily Traffic (Vehicle/ Day)	18,500	13,000	10,000	5,500*	4,000
* Count location between Riley-Natoma

Forecast volumes...not much due to build-out environment...just background growth...nominal

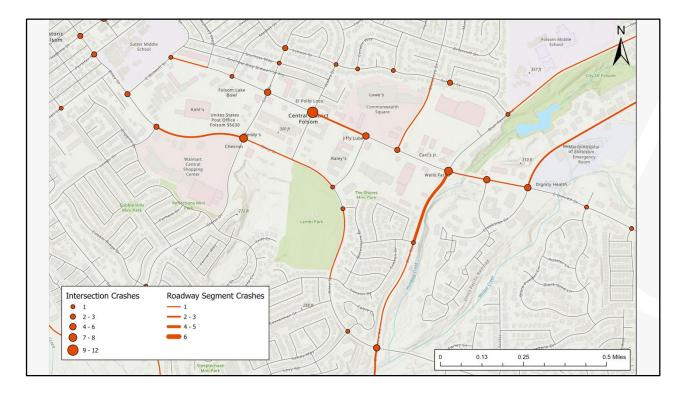
Crash data was obtained from UC Berkely's Transportation Injury Mapping System (TIMS) for the following study period: January 1, 2020- December 31, 2023 (4 years). The TIMS dataset includes injury crashes collected by City of Folsom PD and CHP.

E Bidwell St – 26 Crashes, about 50% rear ends, 25% broadsides. 2 ped crashes. 2 head on.

Riley St – 21 Crashes, about 25% rear ends. 50% broadsides. 5 bike crashes. 3 head on.

No segment crashes along Wales, Orchard or Glenn Drives.

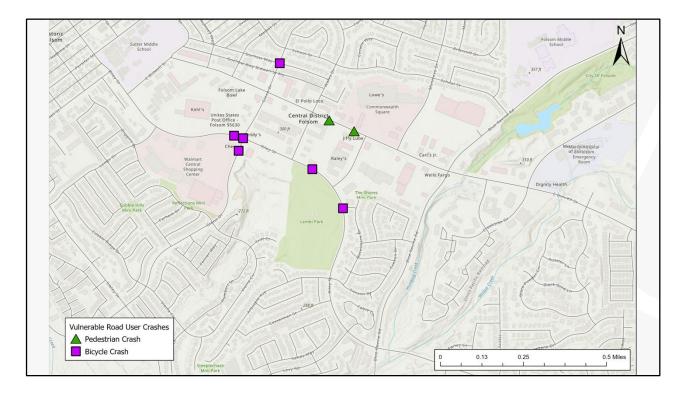
Intersection with the most crashes: E Bidwell St and Wales Dr

- 9 Crashes
- 1 Severe Injury crash (broadside)
- 5 Broadsides, 4 Aggressive-Driving related

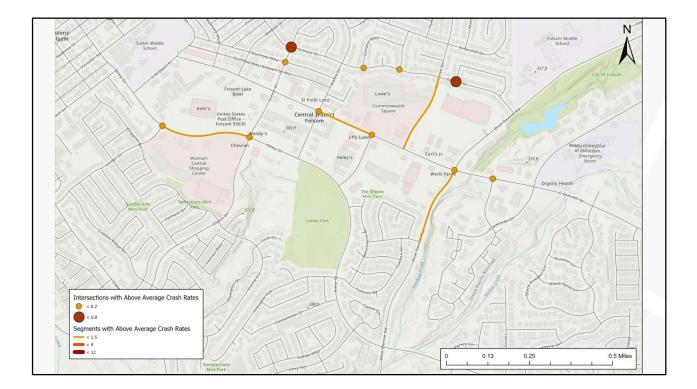
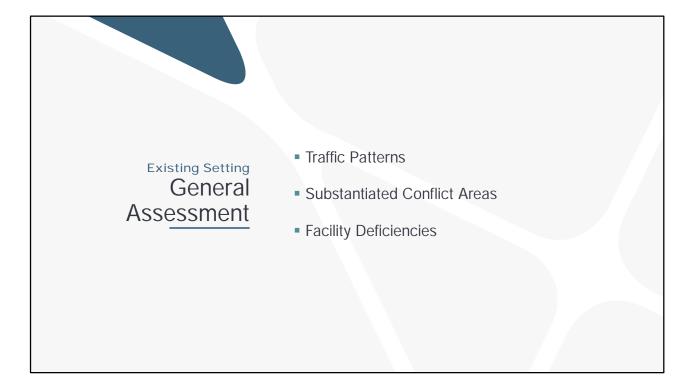
- Two pedestrian crashes on E Bidwell St between Orchard Dr and Wales Dr
  - o 200' west of Orchard and E Bidwell St
    - Severe Injury; Unclear how it happened; both the truck and the ped were NB. Vehicle at fault.
  - o 300' East of Wales Dr and E Bidwell St
    - Other Visible Injury. Ped EB, Car SB, car at fault for violating pedestrian ROW.
  - Recommendation: pedestrian crashes are likely related to pedestrians crossing driveways and jaywalking. Providing mid-block crossings with pedestrian refuge islands could help prevent jaywalking and act as a traffic calming measure. The City could also install a raised median with pedestrian fencing, and install cut-throughs to allow some access to driveways. Rear-ends are the most common crash type; possible countermeasures include signal timing improvements for the corridor, traffic calming measures to address speeding.

- Five Bicycle crashes along Riley St. All broadsides. Two other visible injury, 3 complaint of pain.
  - o 3 crashes at Riley St and Glenn Dr
    - Two crashes involve a vehicle making a right turn and hitting a bike travelling in the same direction.
  - 1 crash between Orchard Dr and Wales Rd
    - Bike at fault, making unsafe Left turn into driveway
  - o 1 crash at Hazelmere Dr
    - Car making Right turn, hits bike. Bike was on wrong side of road.
  - Recommendation: intersection treatments for bikes, buffered bike lanes, green bike lane treatment. Broadsides are common along the corridor, so median treatments with access control could be useful.

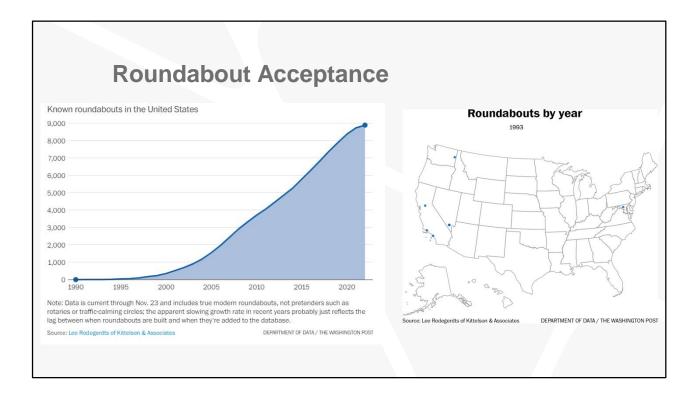
The use of <u>modern roundabouts</u> has been proven throughout the world, and increasingly across the U.S., to be an effective measure of

- reducing vehicular speeds,
- Reducing the number and severity of collisions
- reducing vehicle emissions,
- providing a safer environment for pedestrians and bicyclists

—often at a <u>long-term cost that is significantly lower</u> than the signalized, conventionally configured alternatives.
