VINTAGE AT FOLSOM
 103 EAST NATOMA STREET
 AT FOLSOM PRISON ROAD
 SITE IMPROVEMENT PLANS
 EXISTING CONDITIONS
 CITY OF FOLSOM CA

VINTAGE AT FOLSOM
103 EAST NATOMA STREET
AT FOLSOM PRISON ROAD
SITE IMPROVEMENT PLANS
DEMOLITION & TREE
REMOVAL PLAN
CITY OF FOLSOM CA

VINTAGE AT FOLSOM
103 EAST ENATOMA STREET
AT FOLSOM PRISON ROAD
SITE IMPROVEMENT PLANS
TREE PROTECTION PLAN
CITY OF FOLSOM CA

Subject: Arborist Inventory Letter Report for 102 Natoma Street, City of Folsom, CA

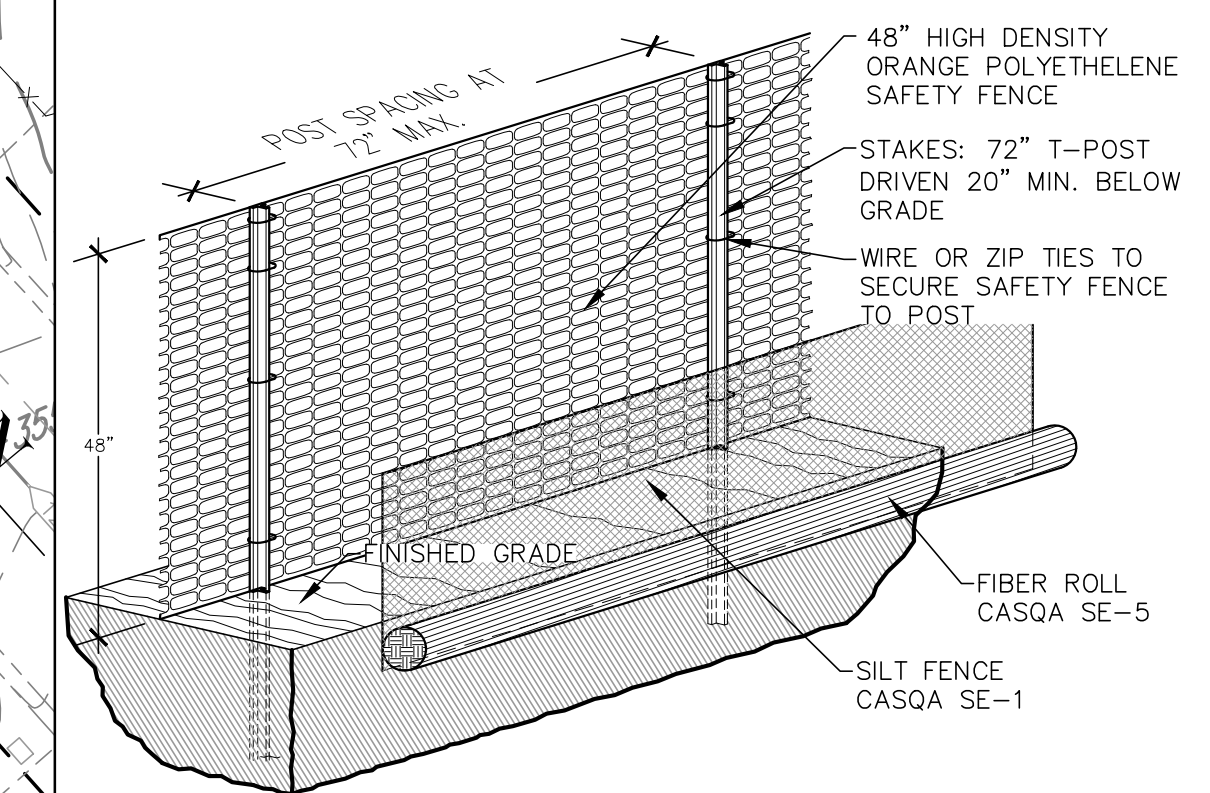
DETAIL A - PERIMETER EROSION CONTROL FENCE

1. ALL DRAINAGES SHALL BE PROTECTED AS PER PLAN.
2. UPGRADIENT FROM THE 48" FENCE (OPPOSITE SIDE OF DRAINAGE) PARALLEL AND ADJACENT TO THE 48" FENCE A FIBER ROLL AND SILT FENCE SHALL BE CONSTRUCTED TO PROTECT THE DRAINAGE FROM DISCHARGE.
3. SAFETY FENCE SHOULD BE FASTENED SECURELY TO THE T-POSTS.
4. THE FENCING MUST REMAIN IN PLACE DURING ALL PHASES OF CONSTRUCTION; ANY CHANGE OF THE PROTECTIVE FENCING MUST BE APPROVED.

- 2 PERIMETER EROSION CONTROL - SEE DETAIL A SHEET C2.2
 - 3 TREE SHALL REMAIN
 - 4 TREE SHALL REMAIN WITH AREA(S) OF DRIP LINE ENCROACHMENT:
 1. TREE FENCING PROTECTION REQUIRED PRIOR TO AND DURING CONSTRUCTION. SEE LANDSCAPE PLANS DETAIL F ON SHEET L2.3.

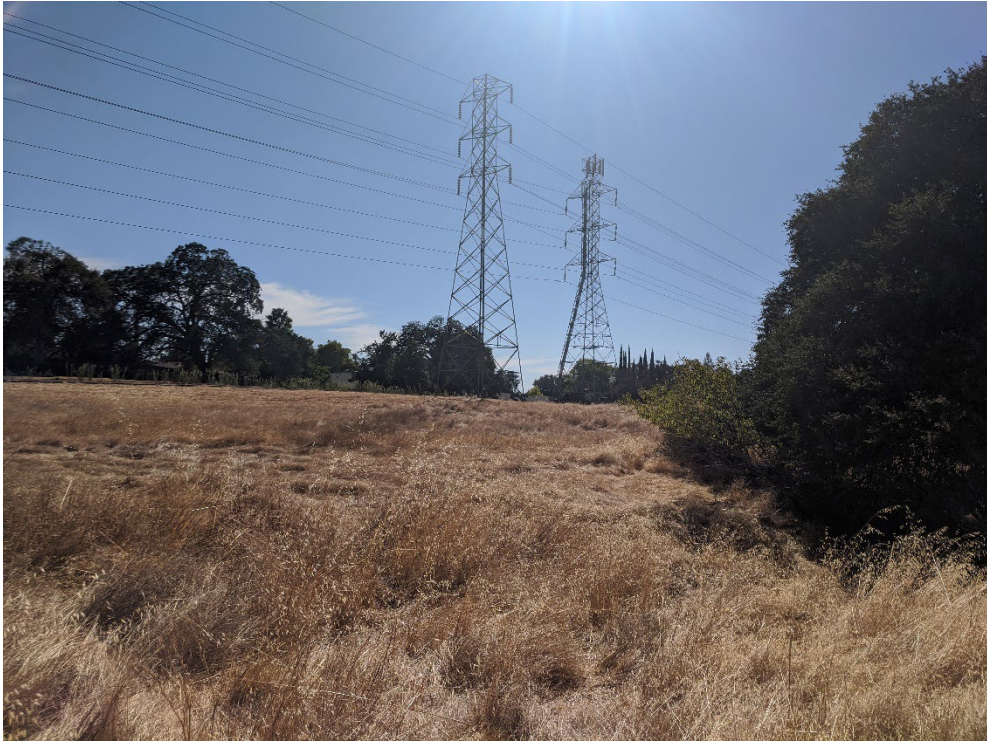
Photo 5: View of electrical towers along the southern boundary of the project site. Photo taken facing southwest.

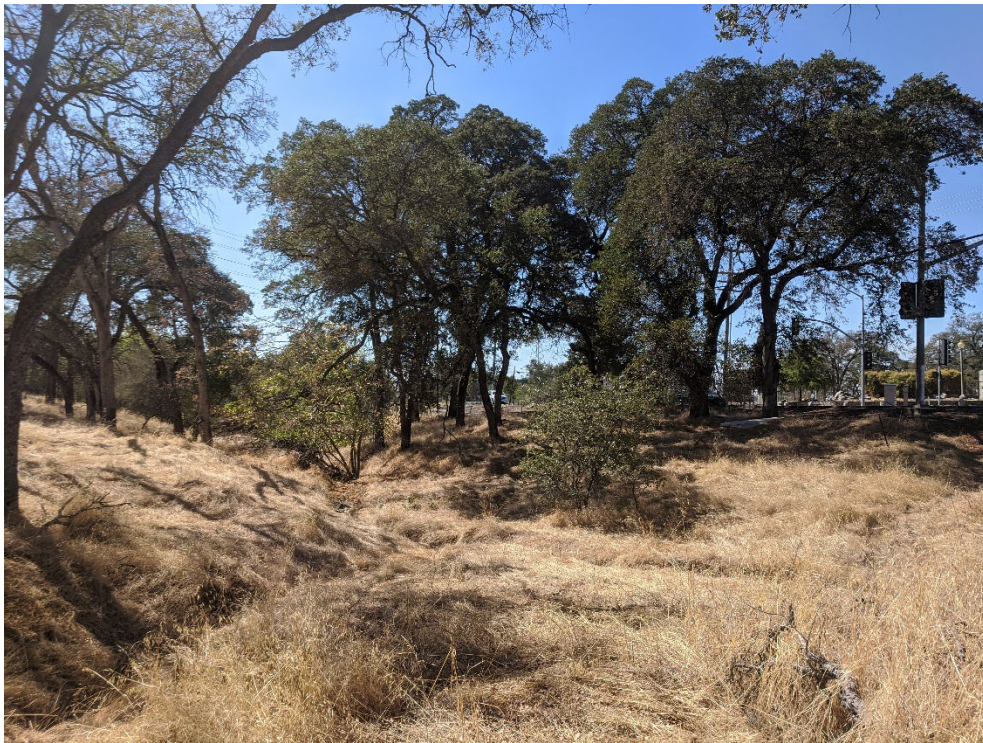
Photo 10: View of the "Y" intersection of the intermittent and ephemeral drainages on the project site. Photo taken facing west.
