WATER QUALITY EVALUATION

Technical Memorandum

B&V PROJECT NO. 406304

City of Folsom

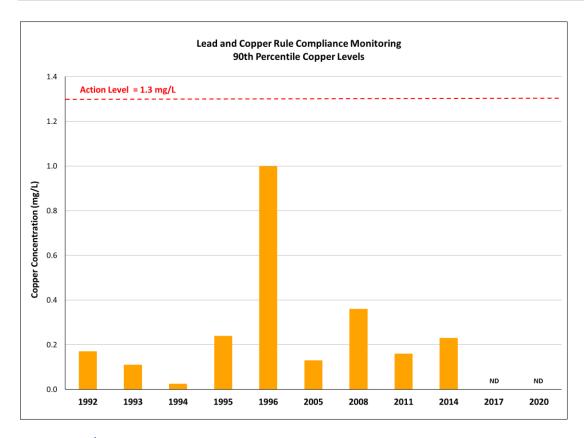
Figure 1: 90th Percentile Copper Results from LCR Monitoring

Both the 2017 and 2020 LCR monitoring periods resulted in non-detect levels of copper as shown in Figure 1. Figure 1 displays the 90th percentile value for which compliance is based on with respect to the copper action level of 1.3 mg/L for each round of LCR monitoring.

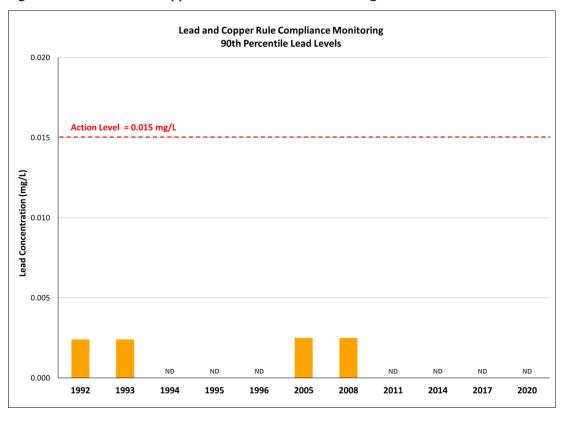
Figure 2: 90th Percentile Lead Results from LCR Monitoring

The 90^{th} percentile value for lead has been non-detect and well below the lead action level of 0.015 mg/L since 2011 as demonstrated in Figure 2.

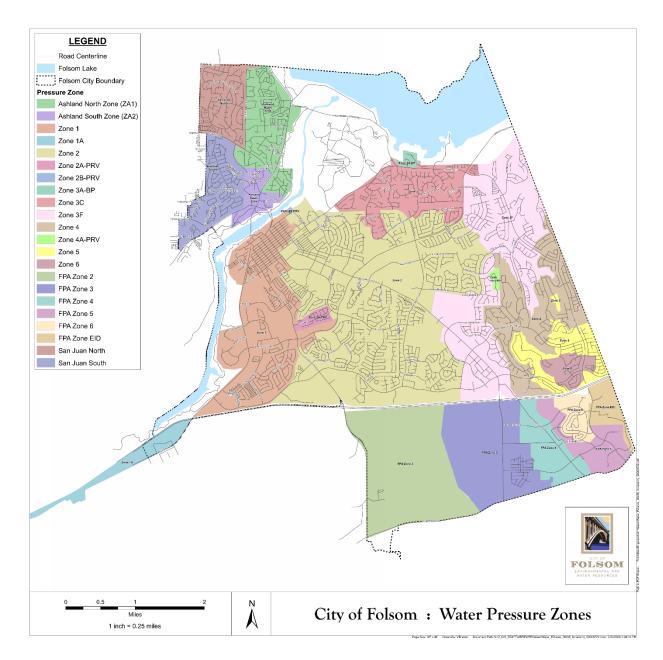
Figure 4: Map of the City's Pressure Zones in the Distribution System

The pin hole leaks have mostly been observed in Zone 1, Zone 2 and Zone 3 of the City's distribution system. A map of the City's system with pressure zone designations is shown in Figure 4. Three separate graphs were developed to display changes in pH from the entry point to the main reservoirs that serve each of these pressure zones. Figure 5 shows the average daily pH at the entry point and the daily grab sample pH from the South Reservoir in Zone 1. Figure 6 shows the average daily pH at the entry point and daily grab sample pH from both the East Reservoir and the Tower Reservoir in Zone 2. Figure 7 shows the average daily pH at the entry point and the daily grab sample pH from the Cimmaron Reservoir in Zone 3.

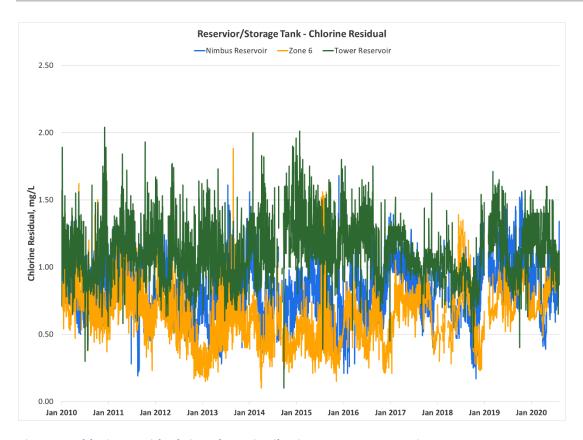
Figure 8: Chlorine Residuals in Select Distribution System Reservoirs

Chlorine residuals were tracked throughout the distribution system as shown in Figure 8, where Tower Reservoir is near the entry point to the distribution system while Nimbus Reservoir and Zone 6 Reservoir are at the edges of the distribution system and have experienced longer water ages and thus slight degradation in chlorine residuals.

Zones 1, 2, and 3 are located closer to the WTP and therefore have slightly higher chlorine residuals than areas further from the WTP, which could be the reason that most of the pin hole leaks have been detected in the areas closer to the WTP. Chlorine is a strong oxidant that is important for corrosion, so it is reasonable that areas with higher chlorine residuals would experience pin hole leaks faster than other parts of the distribution system. As a comparison, chlorine levels near the WTP could average 1.2 mg/L whereas chlorine levels further from the WTP could average 0.8 mg/L. While 1.2 mg/L is a higher value than 0.8 mg/L, the 1.2 mg/L is not considered a "high" value in drinking water systems where the maximum residual disinfectant level can be up to 4.0 mg/L.

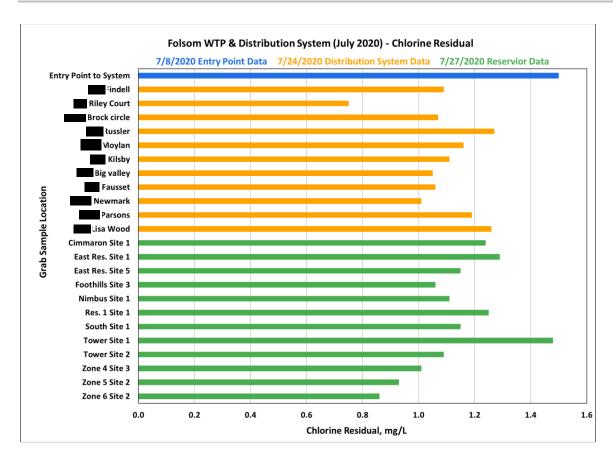
Figure 10: Chlorine Residual from WTP, Reservoirs & Distribution System Grab Samples in July 2020

Chlorine residual data were also plotted in this manner to display how water quality changes throughout the distribution system as shown in Figure 10. It is clear that water quality in the Tower Reservoir is very similar to the entry point data, and then the chlorine residual continues to decrease slowly as it passed through more of the distribution system.

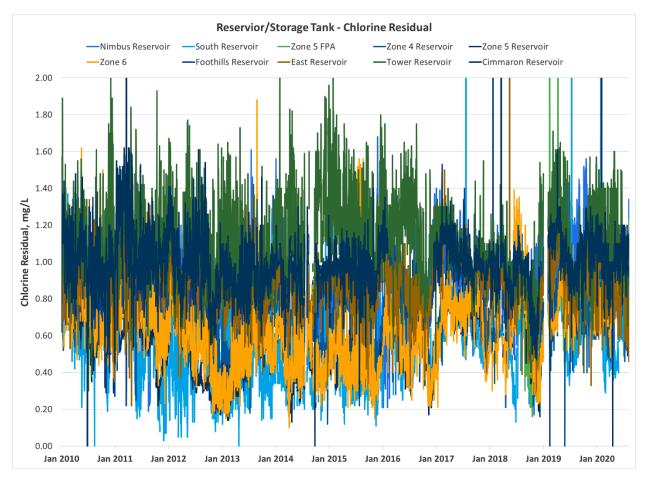
Figure 12: Chlorine Residuals at Reservoirs and Storage Tanks Throughout the Distribution System

Figure 12 shows chlorine residuals measured at reservoirs and storage tanks throughout the City's distribution system using online analyzers from 2010 to 2020. Figure 13 shows the seasonal temperature changes throughout the system, and just the data from Tower Reservoir are displayed to improve the interpretation of the data from 2010 to 2020.

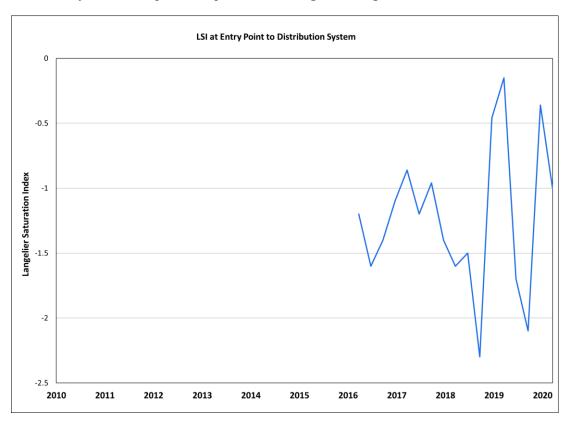
Figure 22: LSI Calculated from Grab Samples Collected at the Entry Point to Distribution System

The City's operating permit for corrosion control treatment uses lime addition to adjust pH as a way to achieve a desired LSI target. In order to increase the LSI, the City increases the concentration of lime to increase the finished water pH, which also results in increases in alkalinity and calcium that further increase LSI. The City has operated the WTP to meet its permit for finished water quality, and the City raised the pH to keep LSI from being more negative.
