April 25, 2024

PRELIMINARY ARBORIST REPORT, TREE INVENTORY & PROTECTION PLAN

RE: 603 Sutter Street, APN #070-0111-010-0000; City of Folsom jurisdiction, California

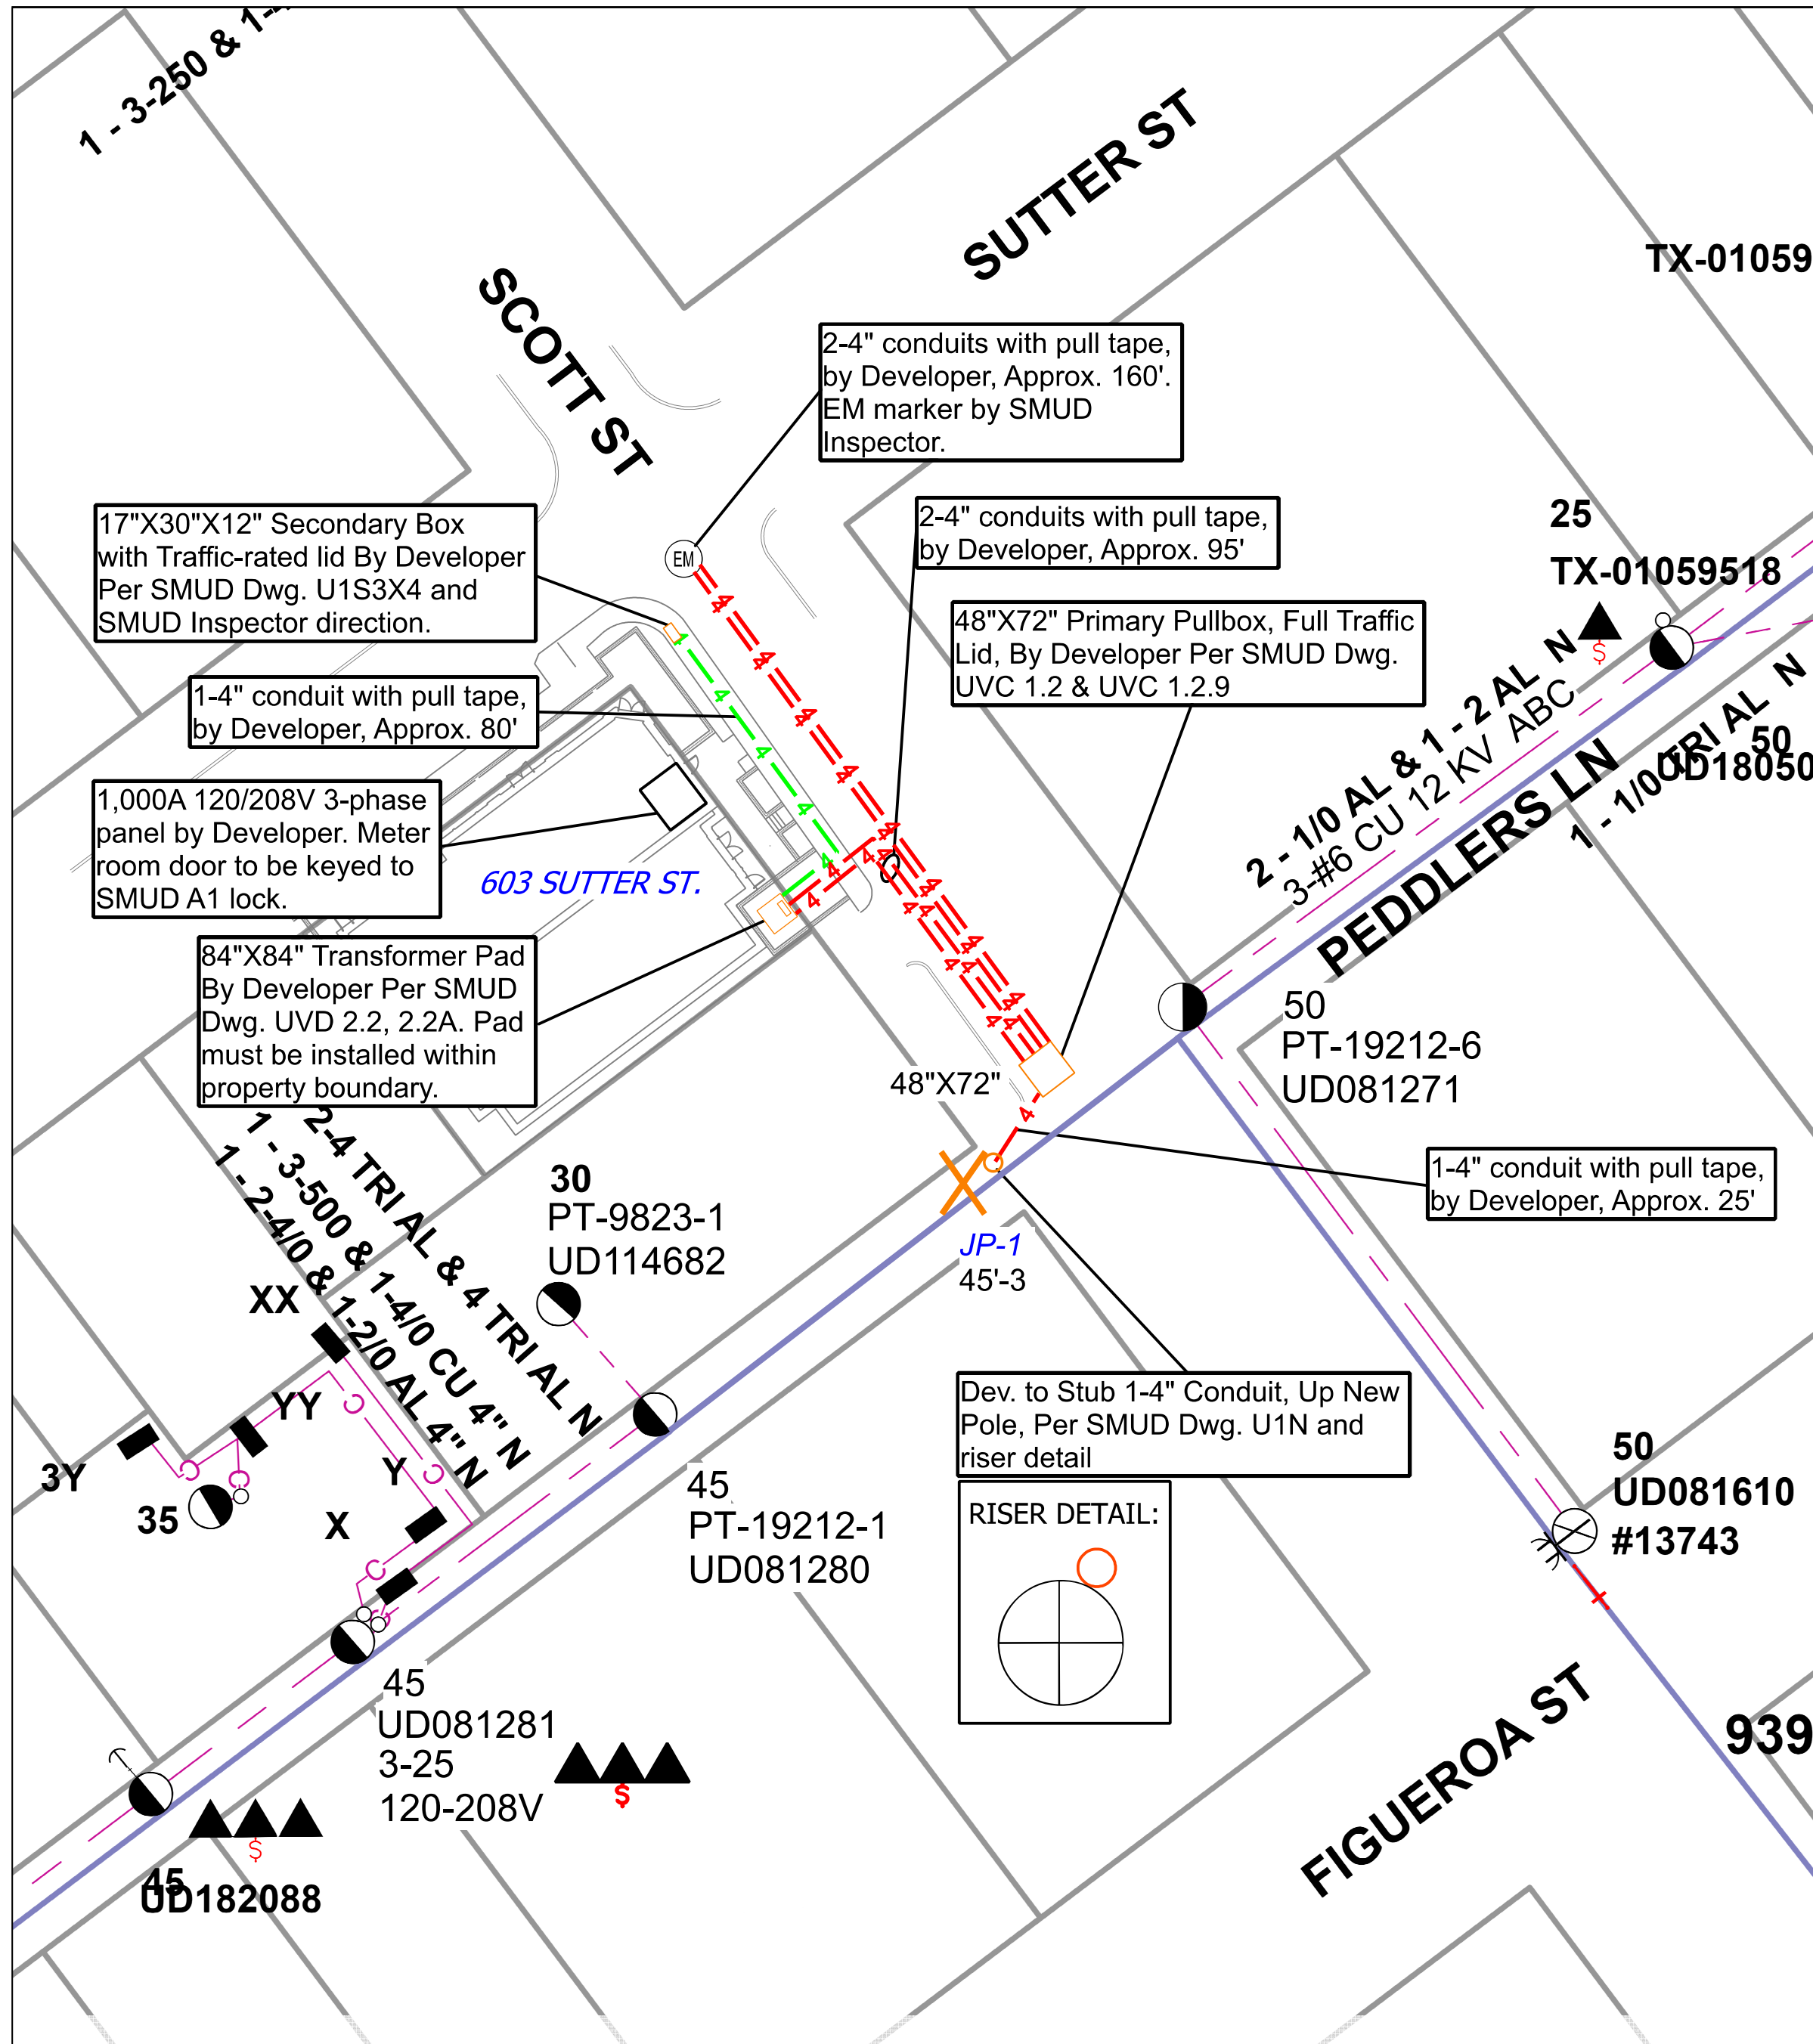
EXHIBIT A - ROOT PROTECTION ZONE FOR TREE #1437 OVERLAYED WITH DEVELOPMENT ELEMENTS WITHIN THE VICINITY

This letter is to provide a rationale for the removal of Tree #1347. It has been determined to be infeasible to retain this tree due to the proposed development activities approved by the City of Folsom in the Exhibits of the Final Conditions of Approval for 603 Sutter Street (PN 17-145, dated 09/06/2023).

4. Street Improvements on Scott Street: One of the conditions of the Entitlements approval were public frontage improvements at Sutter Street and Scott Street. This included the continuation of the sidewalk up Scott Street. It would not be possible to continue the sidewalk along the entire Scott Street as it falls within RPZ.

Considering these restraints, the design team reviewed potential options to reconfigure site elements (including ending the proposed sidewalk improvements mid-block on the Scott Street frontage) in attempts to save tree #1347. Prior to learning of SMUD’s required transformer size and clearances, the design team may have had a path to retain this tree. However, with the addition of the utility transformer, It was found that we would have to substantially reduce the building square footage in any attempt to reconfigure the site design to retain the tree, which would render the development infeasible from a project economics standpoint, and would substantially alter the project from the Design Review-approved Entitlements drawings.
